Eric the Viking – a restoration in many parts – April 2017

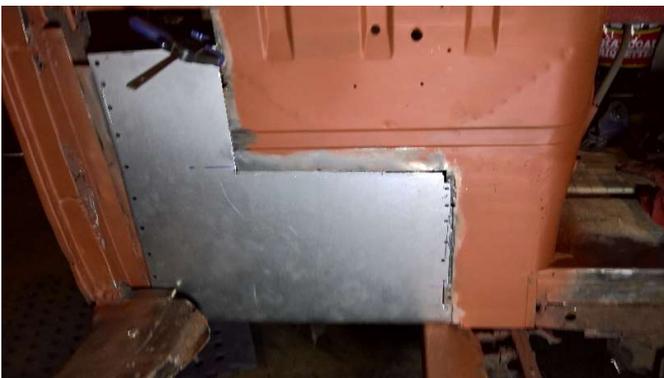
Seat tub with new piece

From a pragmatic point of view, a flat piece of metal is faster and easier to fit. Out came the scallop for your toes using the angle grinder, making the hole a lot bigger. The last of the dish is part of the bulkhead under the seat and is 2mm structural steel. That needed addressing first to make it flat. A cardboard template helped get the shape correct before welding. Once that was flat, the hole between the walk through and the wheel arch was filled and rubbed down leaving the big hole at the back of the wheel arch. This was measured and cut from a new sheet of 1mm steel with a mix of seam welding (edges together and much blowing of holes) and joggled welding (one is overlapped across the other). Once in place there is a lot of rubbing down and then more weld going on to get the right smoothness, which should get less as I continue my experience.

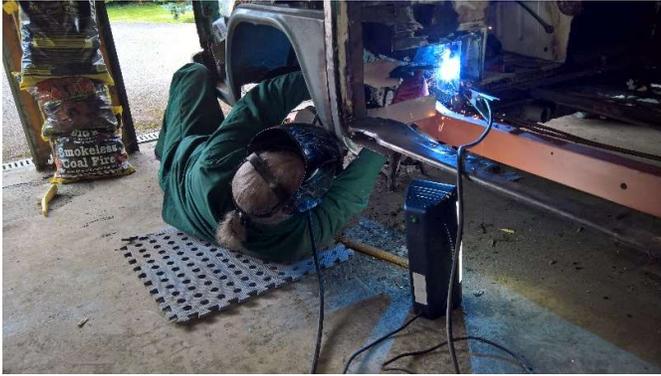
Welding action shot

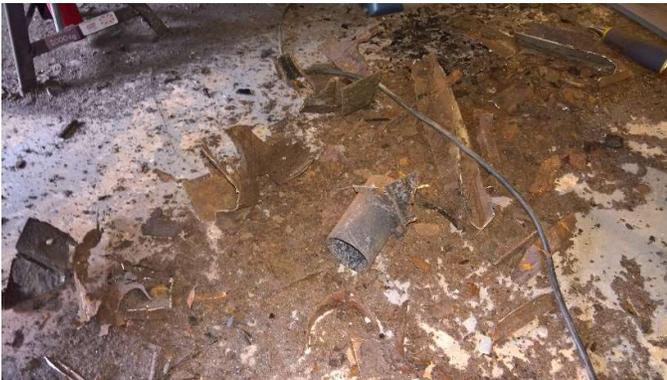
What is left of the front cross member

Predictably, this piece was in a terrible condition, yes the bits in the picture really are what is left of that part. It still took an hour of sweat and wriggling to move around and chop it out with a cutting disk. The inside edge of the near side chassis looks to be ok, the inside edge of the offside chassis member is still hiding under 44 years of accumulated rust and is a job for another day. The outside edge of the offside chassis member where the jacking point connected has not fared well and is badly holed through 2mm steel and will need the same treatment as the other side that I did last year. The last time put my heart in my mouth and it looked to be terminal for the van, now my experience or my gung-ho attitude are saying crack on. This chassis rail is no match for unlimited optimism, determination, a liberal dose of ambitiousness and probably a dash of stupidity. Repair that hole, weld in the new piece in the middle, chop out the remaining rot of the rails, reveal the next big patch of rot, rust and headaches. Just time to show a picture of the driver's front wheel arch, tyre to right of shot, side of the van to the left. It isn't a leaf, that is all that is left of the end of the sill.

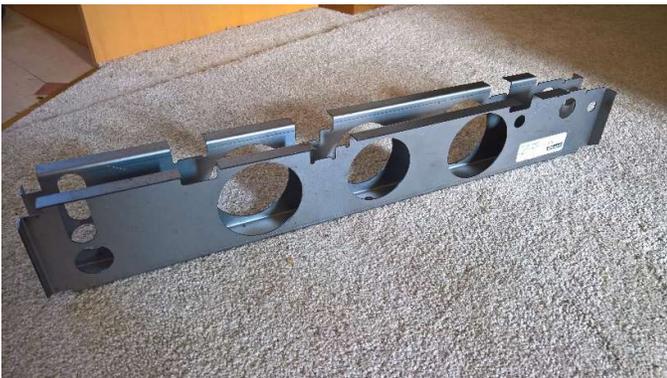
What a new front cross member looks like (hopefully to be fitted soon)

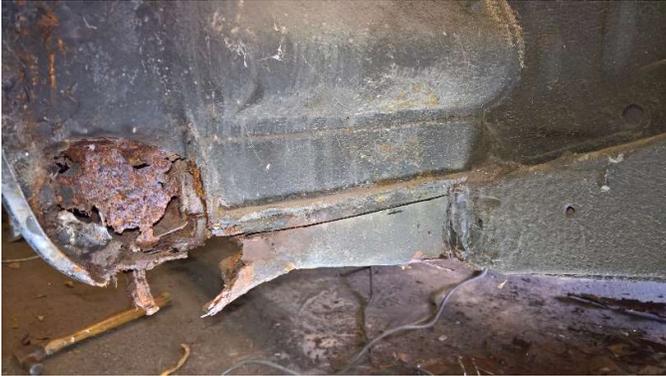
Driver's side front wheel arch
