Eric the Viking – a restoration in many parts – February 2020

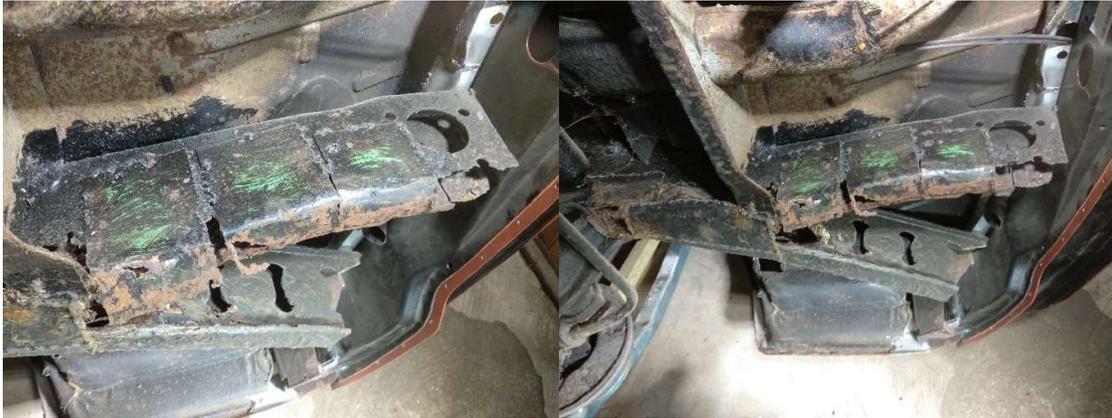
Under the driver's seat, the two main rails split into 2 V-shapes heading up to the front giving 4 sections attached to the front by the bumper. The passenger side / nearside has the remains of the main rail which had rotted out many years ago and had been patched over the top with three plates that did not even meet. A definite MOT failure and with the passage of time, just a mass of rot and underseal now.

The join of the V (left of picture) has been previously plated as well.

The driver's side has fared better but that is not a high bar! Holed in multiple places and in need of serious work. Starting with the passenger side to use any remaining strength on the driver's side, the angle grinder came out but it is painfully slow progress ripping small bits out only to be met with more and more rot behind and underneath. The plan is to remove the chassis rail back to good metal, remove the flat plate between the chassis and the cargo floor then build it back up from this underside.
