Eric the Viking – a restoration in many parts – June 2019

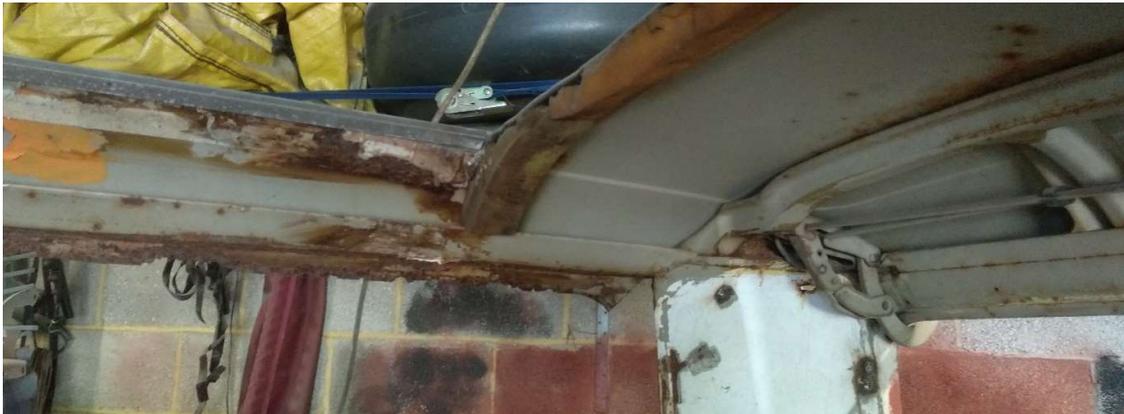
The old roof was inspected, it was originally a panel van and someone had cut a hole in it and added a Paris sunroof complete with the leather ragtop. That had perished significantly and was letting in all of the weather for many years before I bought him. That weather had got into the roof frame and there was precious little of the frame left that was not rotten. The visible outer roof was reasonable on the big surfaces but the gutters were completely rotten too. It really was not salvageable.

I have to admit to getting outside help on Eric’s hat and I called on a Banbury based professional restorer who interrupted the work on his own split screen roof restoration. The theory is actually quite straight forward. Buy a replacement metal roof. Reinforce the vehicle using 3mm wall, 1 inch box section steel welded to all of the posts of the vehicle and braced across each other for strength. Weld guide markers for the front windscreen and rear hatch so that you know exactly where the new roof goes. Choppy chop. Place the new roof on the posts. Weld up.

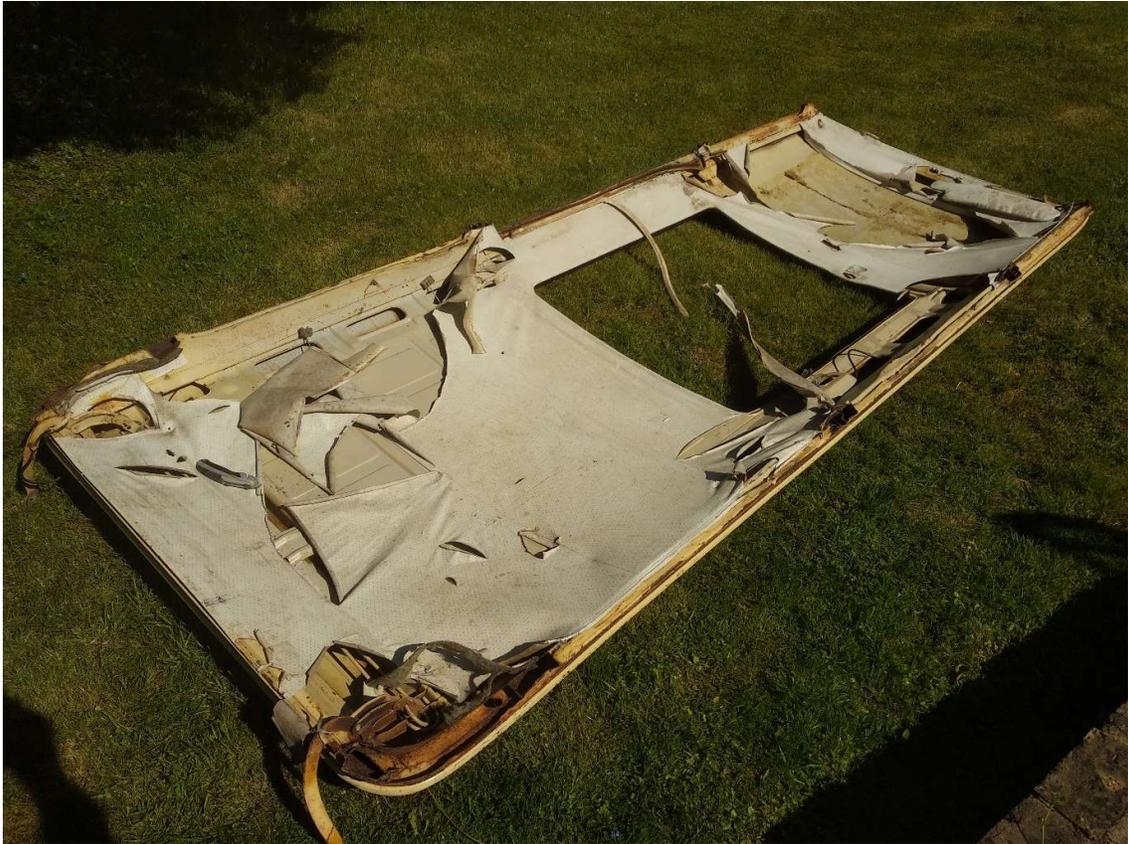
A new roof was found online as a rather dented but not rotten cut from a Deluxe late Bay brought in from California. It came with part of the roof lining, an incredibly dirty sun visor and the wiring for the lights.

The back door mechanism is bent and in need of surface rust removal but a good basis on which to start. Removing the roof lining was easy, manually grinding off the spot welds of the window surrounds was time consuming. Removing the sliding door runner from a left hand drive roof was fiddly since I have a right hand drive sliding door. After about 6 man hours, the roof was ready and my hands ached!
