Eric the Viking – a restoration in many parts – April 2019

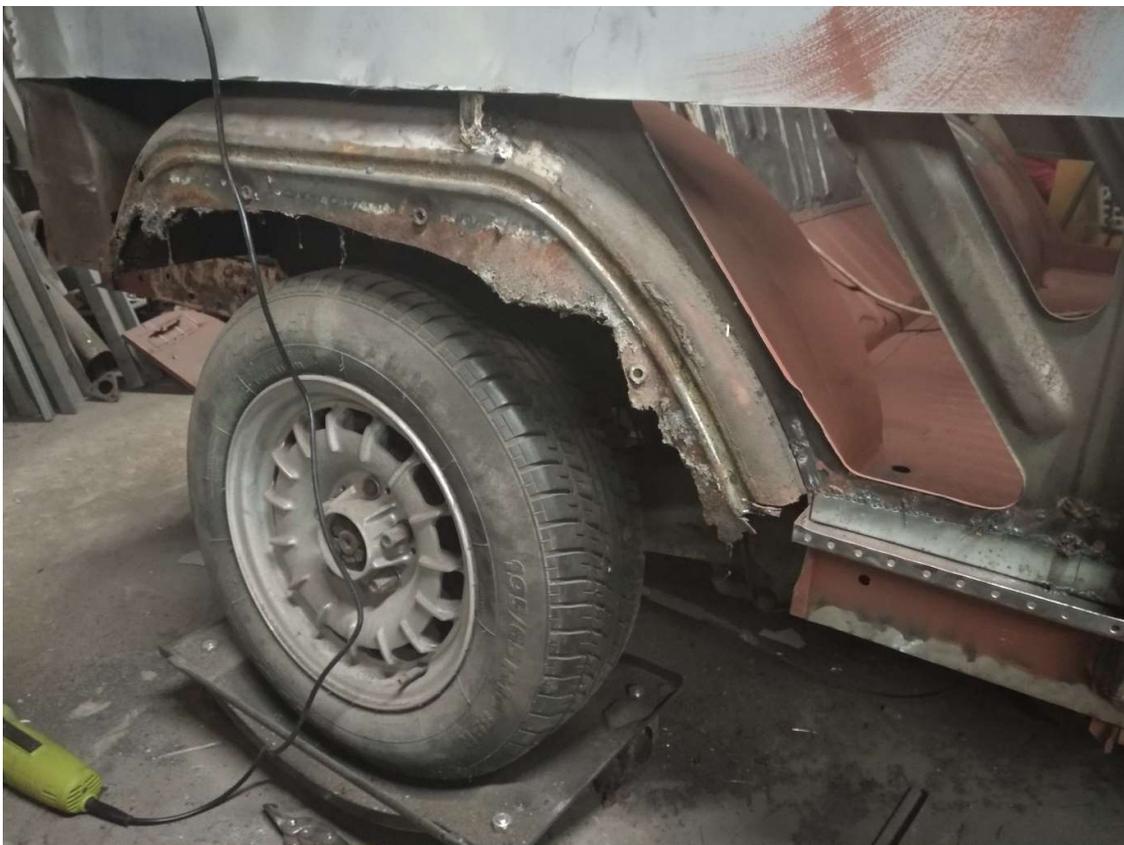
Underneath a lot of filler was a replacement outer wheel arch. That was loosely attached to another outer wheel arch that had been bent to make something approaching an inner wheel arch. That in turn was barely attached to some rust. See the above picture. This time the outer panel was trimmed slightly higher than the other side because it was about 1mm above the line of the previous outer panel. The added advantage that I can attach the new panel much easier as I will discover later. I hope.

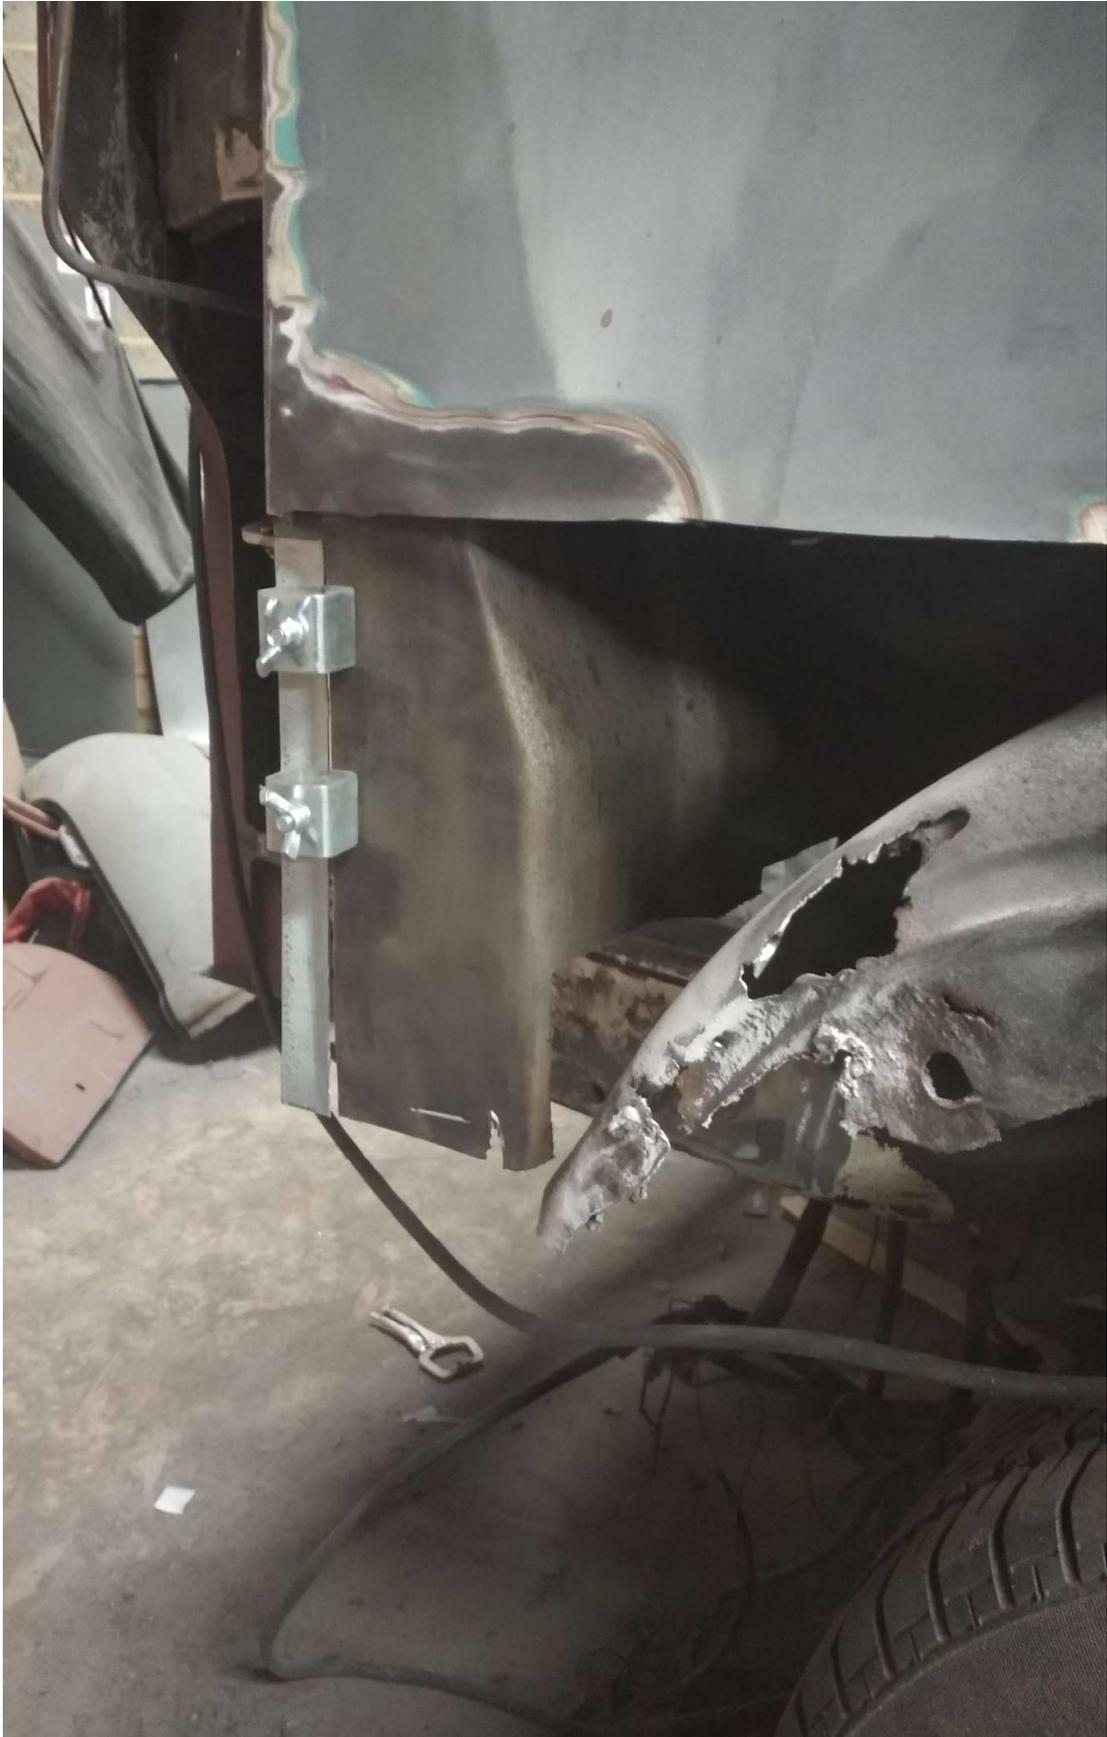
Meanwhile at the back of that wheel arch the outer panel is supposed to attach to the front of vehicle wall surrounding the battery tray. Much of that was missing too.

The box in the middle of the picture was missing its left edge that folds around out of shot. That edge gets the wheel arch panel spot welded to it. Then the rear corner welds to that once the battery tray has been put back in. The new piece is being held in place with my new aircraft clamps that line both pieces of metal up, hold them in place and set the gap between them all in one hit as noted previously.

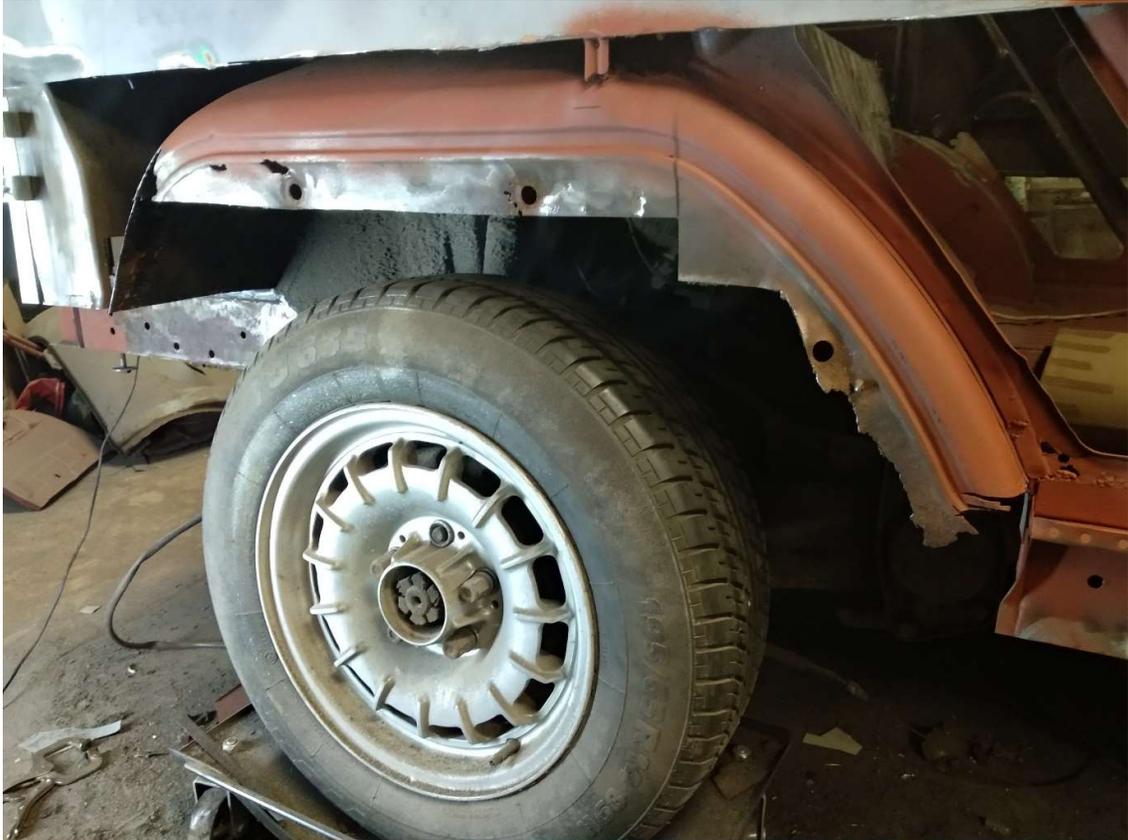
A quick clean of 45 years of accumulated dirt, rust and rot plus a little neaten up of the edges and it looks better already.

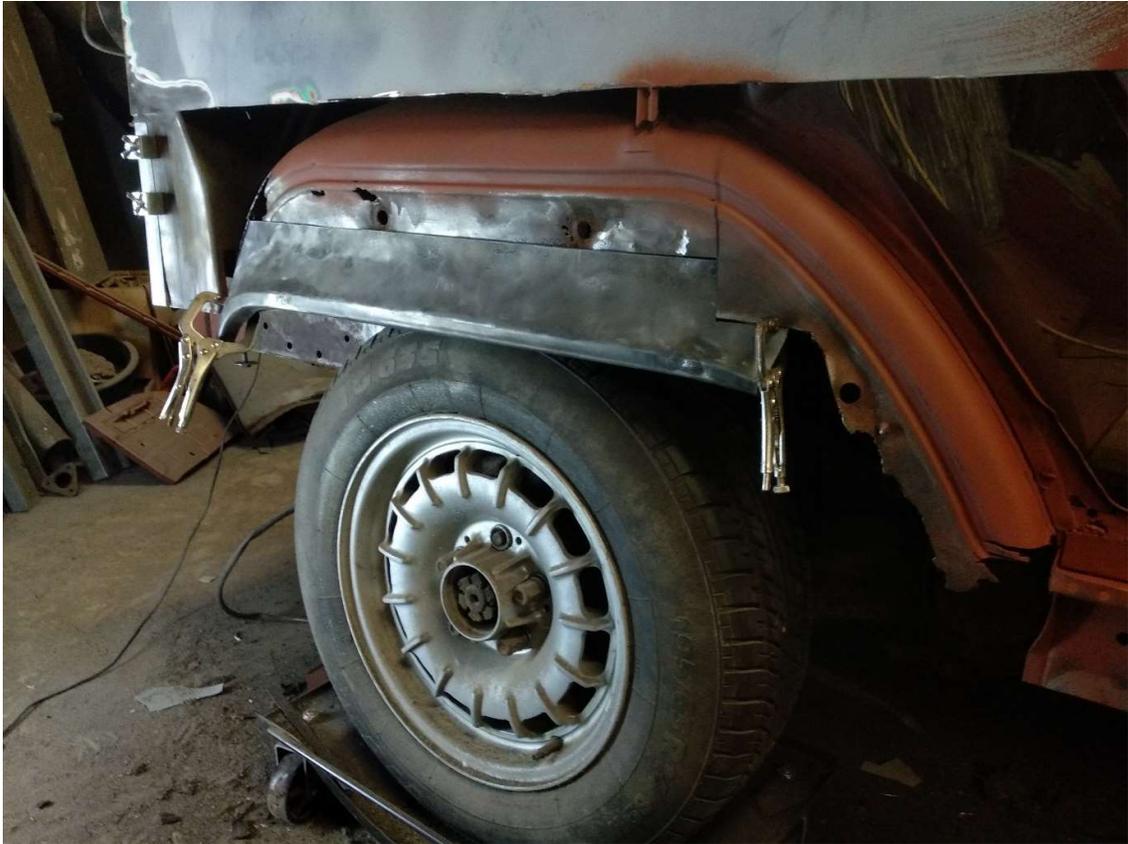
Then I used one of the outer arches suitably trimmed down to fabricate a new inner arch for the piece that I needed and clamped it in place.

I cannot weld that one in place until I know that it is correct forwards and backwards. To do that, I need to trial fit the outer panel. To do that I need to weld in that vertical fold at the back, clean up where the panel meets the C post and the middle panel, then hold the outer panel in place with both hands, whilst holding that inner arch panel in place with both other hands, getting it totally lined up, mark exactly where it needs to go with two other hands, then ideally clamp it in place with further hands. With clamps that take up the exact space where the outer arch has been held in place with my first pair of hands.
