Erik the Viking – a restoration in many parts – 21st August 2016

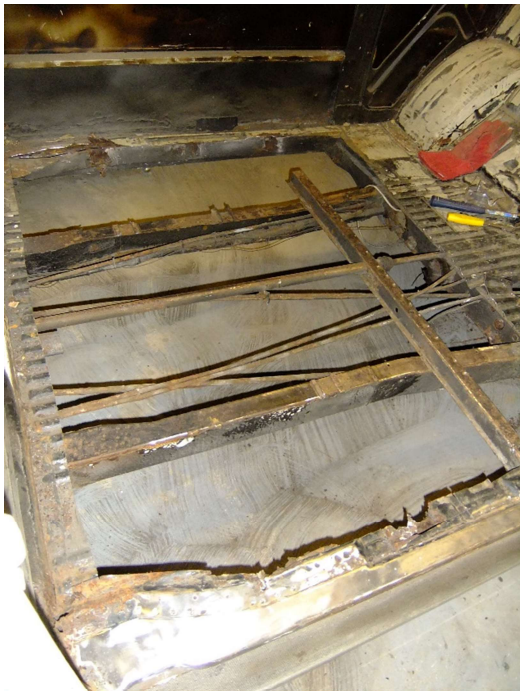
The floor between the top hats was cut out into rectangles, and then the floor that was welded to the top hats was drilled out. Top tip – spot-weld drill bits are annoying, an air chisel would have been better. Two of the top hats were removed and the third, rearmost one has lost the outer six inches or so. Since you cannot buy just the ends, it will probably also come out. Then came the chopping out of the sills. Removing the top hats ended up with a hammer causing poor Eric to rain rust from multiple places underneath! Both support beams feel like papier mache but used to be metal and need replacing. All outriggers and jacking points are in a similar condition. The nearside chassis rail has started to go where the front support section has rotted away, too.

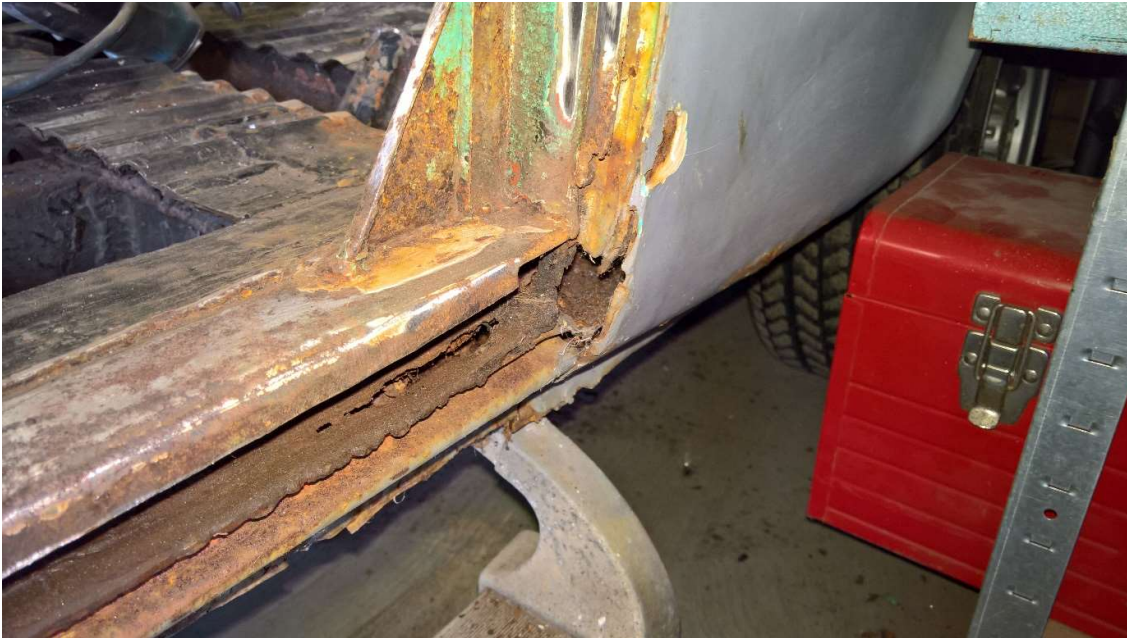
The nearside sill was nearest the work area - keep me covered, I'm going in! Chop off the outer sill which is only a trim panel it says. Check. Then cut horizontally through the middle sill from the outside and the inner sill from the inside. Erm. The middle sill is missing barring the front six inches and even that is frillier than my Friday night outfit. The inner sill is there for the most part but at crucial points is either filler, fibreglass, underseal or holes - rarely good metal - and given my size it is not easy to get to the right angle to chop it, but progress is being made.

Once the nearside sills are fully removed, the whole lot will be replaced barring the top of the sliding door track and the step that it sits under. This is going to bring much needed strength once the chassis rail work starts.
