Eric the Viking – a restoration in many parts – December 2018

Spend since last report: £1,384. Total hours labour since last report: 74

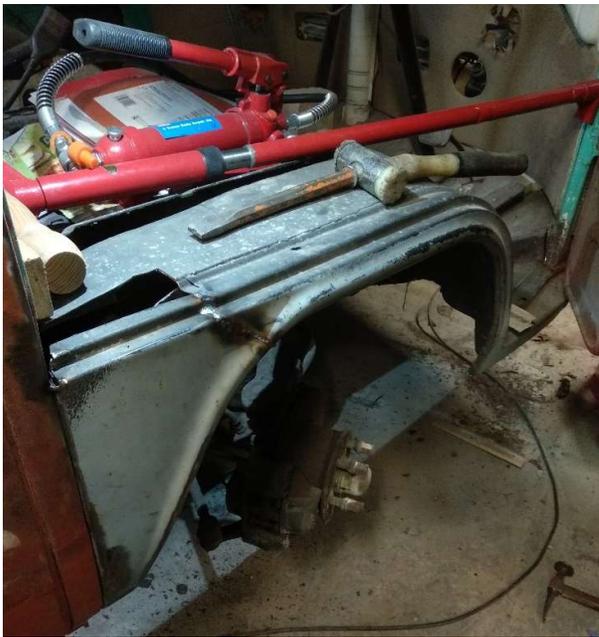
The last picture showed the B post and the toe bulge behind the passenger seat all complete and mainly primed, that has now been primed. We have now finished the other B post behind the driver's seat – another sentence that took two man days to complete! The van had sagged once more and the B post was banana shaped, requiring the Porta Power, removal of the wheel arch and the rotten parts of the seat tub. Rot there is a job for another day. Easing off the metal from the bottom of the step as it hits the A post meant that it was easier to straighten up that side of the van.

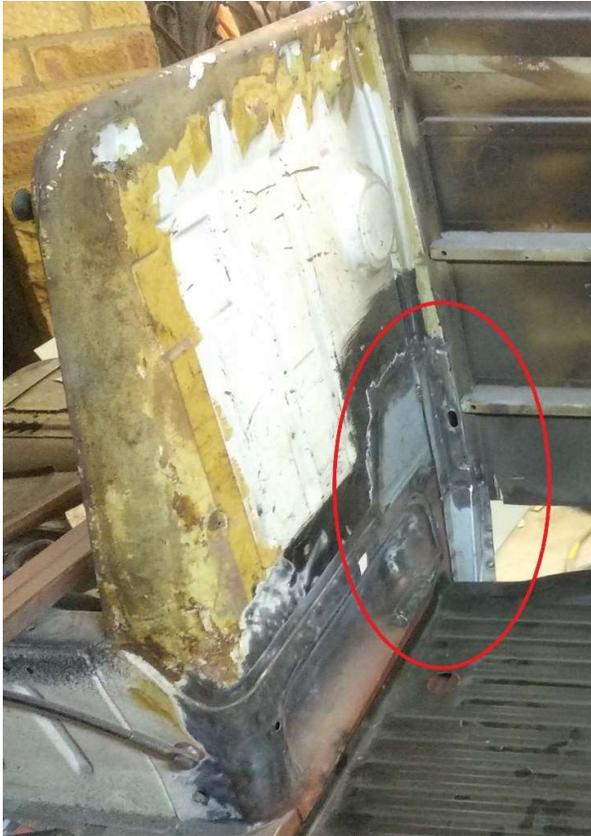
With the Porta Power stretching the door gap to the correct size and the US import door supplied with Eric's purchase making its first appearance, the wheel arch and B post were welded in place to provide strength in that area for the first time in years. Here's the view from inside – the lower 8 inches are new, fabricated inside and a Just Kampers B post outer panel on the outside.

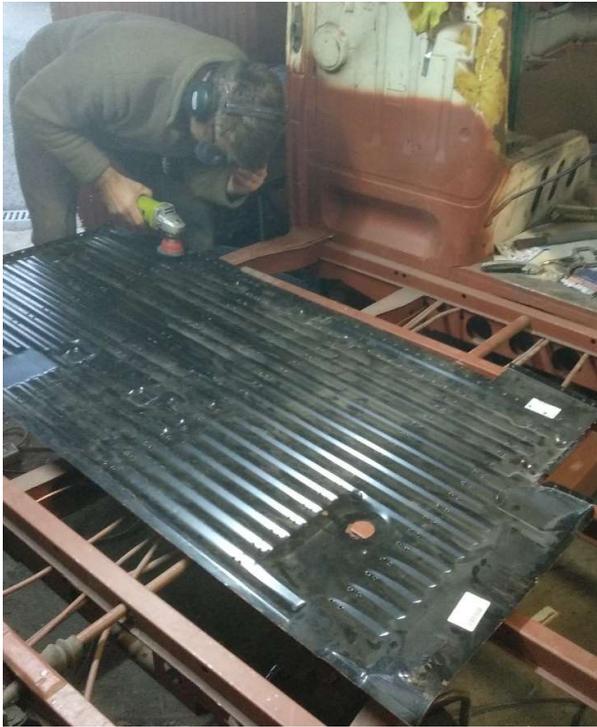
Finally, after far too many hours of trial fitting, we were ready to fit the floor. Two years since the old floor came out and we were excited. "All" it takes to fit a floor is to look at the corrugations on the floor, work out which ones correspond to the cross members, mark and remove the paint on cross members, mark and drill the two 5mm holes for each meeting of the floor and a cross member. Both floor halves. That is a little over 100 holes on each half

which started with a 3mm hole then drilled out to a 5mm hole. Yes, 2 goes at drilling on each of 100 holes on both halves and that was outsourced to my neighbour and great friend Rich. 400 holes drilled later, the last trial fit gave him a cut finger on a jagged bit of metal. You have to grind the rough edges smooth too. On its own, just the drilling and sanding is around five back breaking hours.

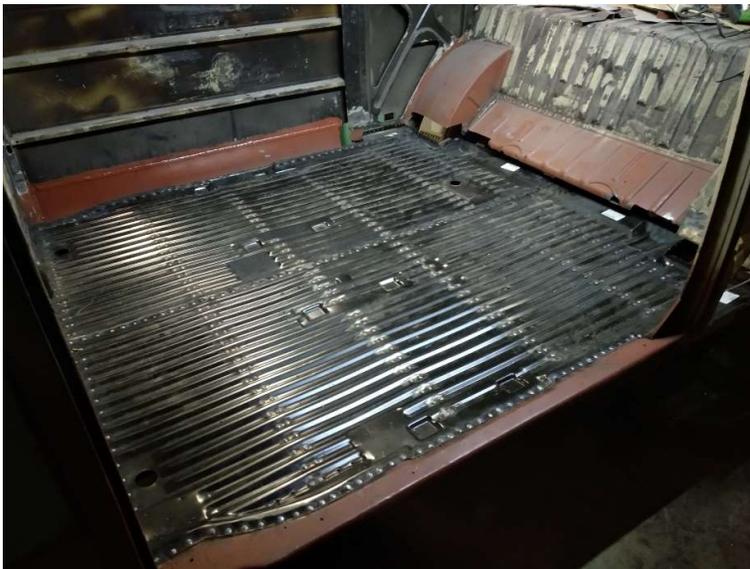
Finally, the floor was welded in.

Welding took around an hour and a half of those same few hundred drilled holes and no grinding has yet happened. Given that they are all in the valleys of the corrugations, they may just get a wire wheel smoothing then some paint! As you can see, around the edges of the

floor, we need to add the LHD to RHD conversion plate on the non-sliding door side to bridge from the middle sill to the body panel – available from Alan Schofield and purchased two years ago. Also need to fabricate and weld in behind the C posts, the bottoms of the inner wheel arches and the rotten edges of the 45 degree panel between the wheel arches. Expecting that will take a couple of days to complete using the latest and greatest CAD assistance. That's Cardboard Aided Design. Template your metal with empty pizza boxes, transfer that to your Zintec lightly galvanized sheet metal and shape with your new hammer and dolly.
