Eric the Viking – a restoration in many parts – June 2020

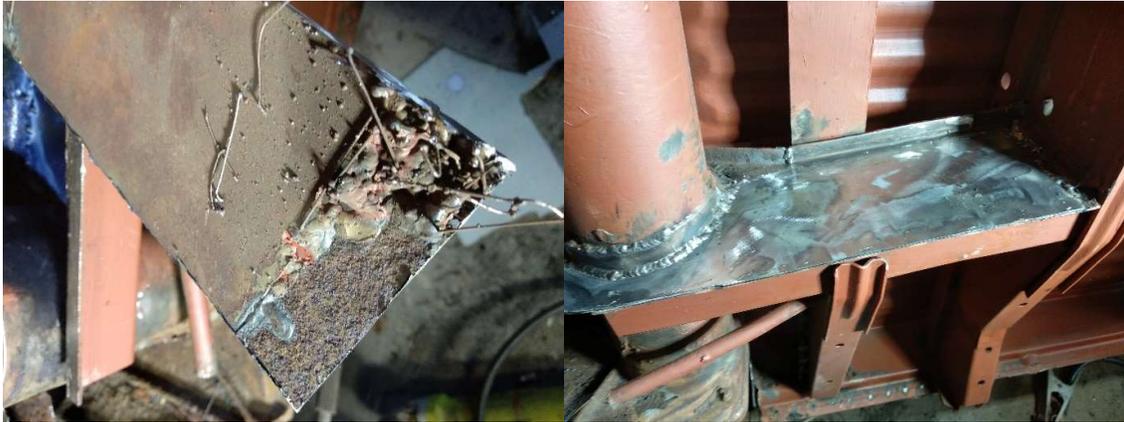
Tidying up some odds and ends. Where the rear chassis meets the torsion tube as noted last time, it was looking poor and was half an inch out of position.

Poor welding inside the box section and new metal welded to badly corroded metal. Chopped it out and replaced it. New 2mm lightly galvanized steel sheet, cut to shape. 6mm holes drilled through it to the rest of the existing chassis box section are then plug welded thoroughly using a hot welder setting to ensure really good penetration as this is a section that needs a lot of strength!

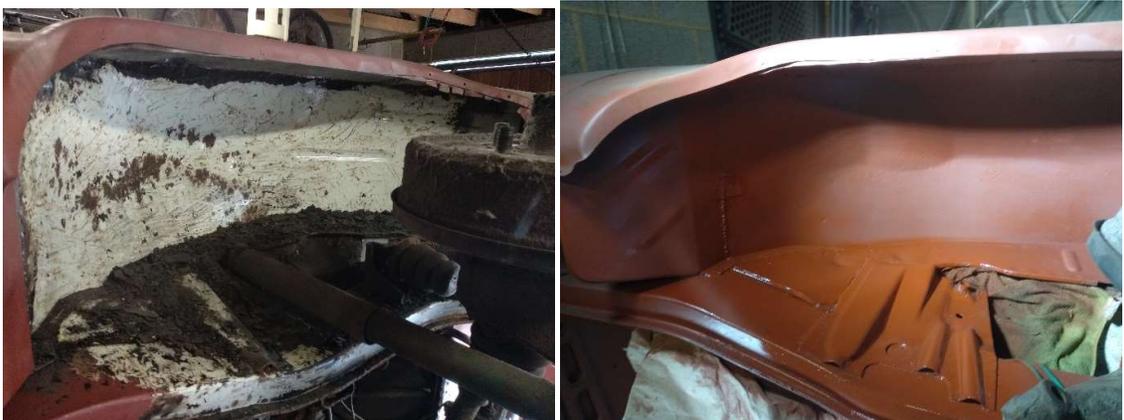
The offside rear wheelarch was fully covered in underseal, presumably well after the horse had bolted since there were lot of big rust spots (middle of the white area which is the top of the inside of the arch). They came off with a wire wheel and received some Kerrust treatment. Rust holes were carefully chopped out and new steel cut to shape and seam welded in to give no visible trace. The whole lot was taken back to bare steel with the wire wheel on the angle grinder and then given two coats of primer and looks rather good.

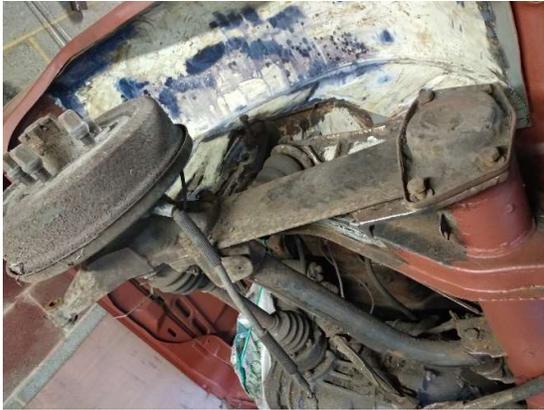
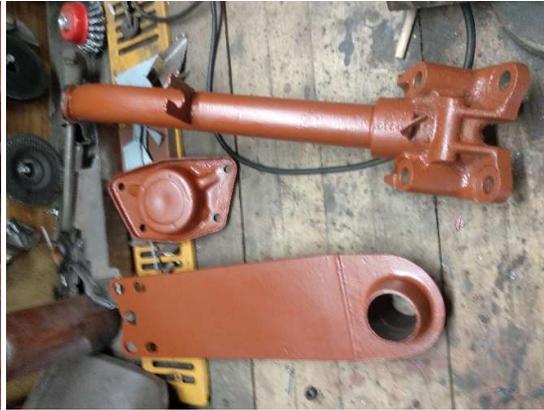
The offside rear suspension is in the air as the van is on his nearside. As I needed to get to all of the bits, it was a good time to dismantle it and it certainly needed some TLC.

The trapezium shaped end cover is only a cover and you can see it in the wheel arch of a Bay window bus just in front of the rear wheels, one each side. It unbolts with 4 bolts and apart from some grease sticking it to the end of the torsion tube, it should come away easily. Eric's one of course was rusty but apart from a half centimetre section that needed a bit of filling with the welder, the wire wheel got it clean. Then behind the road wheel is the brake drum and behind that are 4 big bolts that hold the drum and hub assembly to the axle and the suspension arm. These were about 22mm bolts and I had to call a friend with a socket set that he uses on farm equipment, as of course everything was really rusty and seized.

The bolts finally came out and the suspension came apart. This is big thick steel and was covered in rust, paint, underseal and grease but the angle grinder's wire wheel took it all back to slightly pitted but healthy steel. It all then had a paint with the anti-rust solution followed by two brushed-on coats of anti-rust primer. I think that it looks rather better! No sense reassembling as that will stop access to the inside of the wheel arch that will need its top coat. On dismantling the suspension, there is a rubber stop that looks like a dog's kong toy and stops the suspension banging metal on metal when you go over big bumps. That has seen better days but is probably ok, sadly it sits underneath a mounting that was completely corroded into holes and that is welded to the main chassis rail behind the road wheel and THAT was also badly holed. First picture is the "before" image with the cuts made into the chassis ready to remove it.

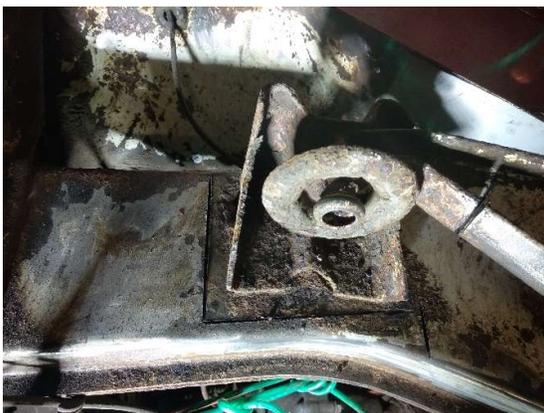
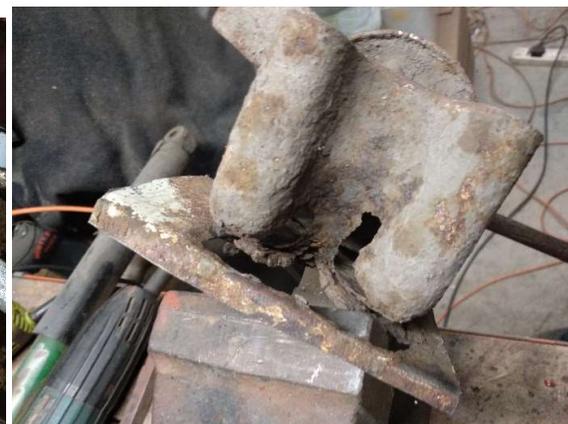
Behind the pictured circle of steel is the mounting bracket, the second picture shows that bracket from above still attached to the chassis box section. Both pieces badly holed and rotting nicely. I cut the chassis box section off the bracket and welded the bracket back together on the bench (see the shiny steel in the next photo!).

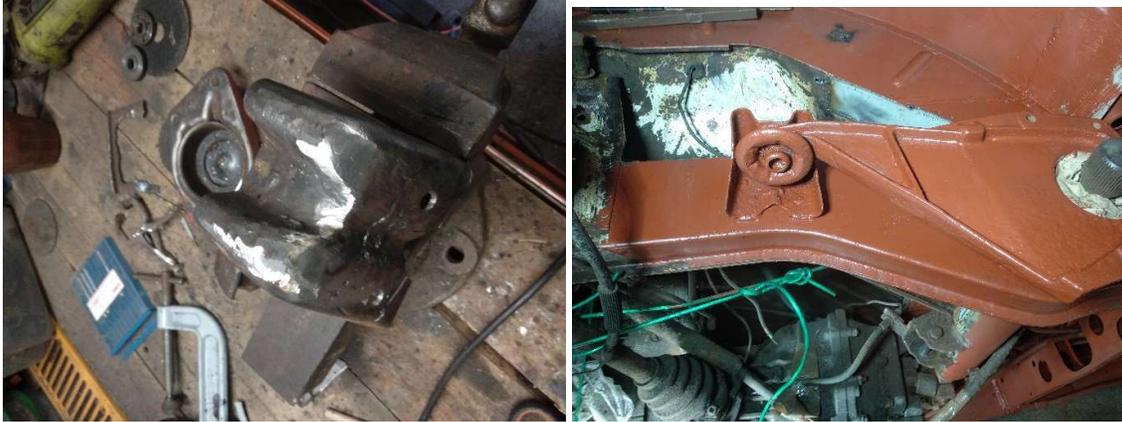
And finally everything welded back together and as ever, anti-rust solution brushed on then two coats of brushed on anti-rust primer. This area gets all the salt and the weather when driving along and needs to be nicely protected. It may not be flat meaning that the top-coat will not be flat, but as Eric will not be concourse, it will look ok and be safe. On top of the top coat will be underseal and anyone who wants to pick me up for having non-perfect paint on the suspension arms under the underseal behind the road wheel is welcome to pass judgement!
