Eric the Viking – a restoration in many parts – October 2016

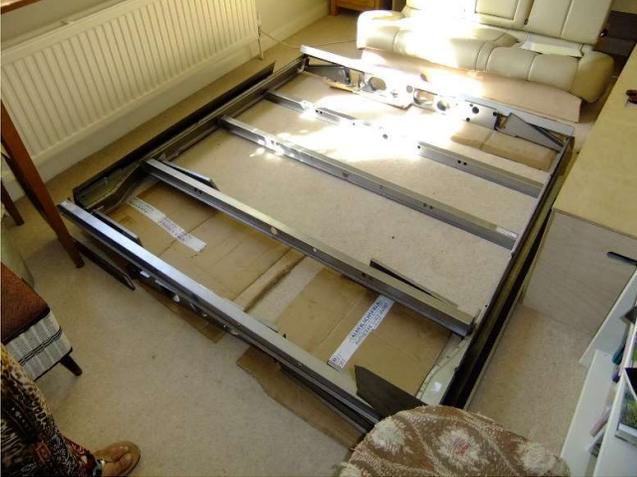
Once the moths had found their way to the light and we stopped coughing from the dust, my wallet was open and used to buy the parts. All outriggers, jacking points, support sections, six top hats, all sills on both sides and the repair sections for the bulges at the back of the front wheel arches for your feet if you are on the middle row of a dormobile bus. It all came beautifully packaged, bare metal covered in grease. I laid it out carefully indoors to see how it all fits. I am still none the wiser but it is a start.

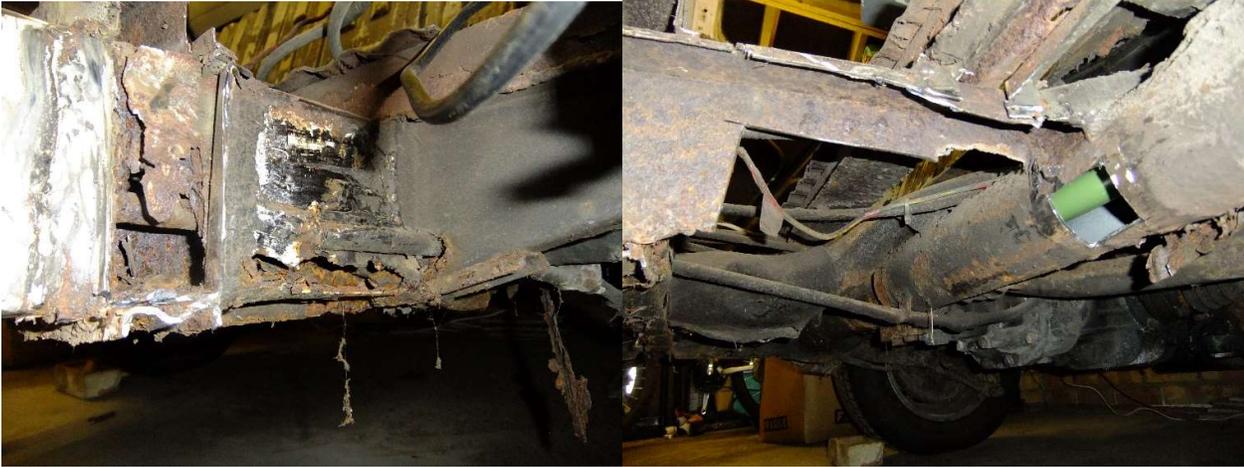
Then we moved back to the rear of the cargo floor area to the join with the rear jacking point. Water has been sitting in there for years and both jacking point and chassis rail at that junction are totally rotten. Jacking point removed, chassis rot removed, patch built. Hmm, not happy with the patch or the chassis rail further back. A good job that we abandoned that plan as the rest of that chassis section is also rotten all the way back to the torsion tube. No, we didn't know what that did either. The big side to side tube just in front of the back wheels with a cover on each end in the shape of a trapezium is the torsion bar but we didn't know what it did, we're only amateurs. Where the chassis meets that tube was all rot and rust, so it all got hacked away with a cutting disk and a grinding disk. Eventually shiny metal was seen on the tube and we cut a little hole in the 2mm metal about 2 inches each way to see what is inside. Gingerly. Green and shiny metal is what we found, seeing the light for the first time in 43 years but the pilot hole piece was half rotted and needs replacing. Almost certainly on the other chassis rail too. Before the rot was removed and after:

Repairing the tube is difficult as access from above is tight due to the rear panel between the wheels and welding in a confined space laid under a rotten bus is just no fun. Next job then is to remove the panel between the wheels.... All the spot welds drilled out carefully and start easing the panel away. Turns out that panel forms part of the fuel tank ledge, so a wasted hour and now need to make that good again.

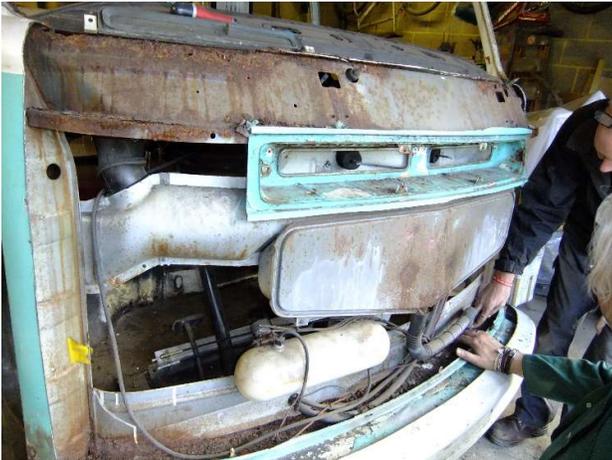
Ok, got some time, want to make progress. Off with his nose!

More weight loss program, chopping from the windscreen down the nose near the edges, leaving the air intake grill and down to the bumper. Looks better already, let's see what is going on underneath. Bumper is ok and reusable. Deformation panel is pretty much dust, the front chassis sections are too, the floor of the cab isn't great and all inner front panels are wrecked too. New plan, don't look at the rest of the bus to see what you have got, fix the current bit only then move on. The path to the end is taken by looking at your feet taking one step at a time not looking at the mountain wondering why on earth you jumped into this money pit in the first place.

The torsion tube can get the patches fitted (steel sheet purchased) then fit the chassis rail patches from chassis rail to torsion tube (chassis repair rails purchased). Then cut off the offside sill to make some room. Then fit the top hats that go side to side of the cargo floor on top of the shiny chassis rails and out to where the new sills will go. The icing on that jigsaw is the new floor. Bracing myself for that one, more credit card bashing but there's a moth heading towards the sun carrying something that looks a lot like a credit card... someone stop that moth!
