Eric the Viking – a restoration in many parts – October 2018

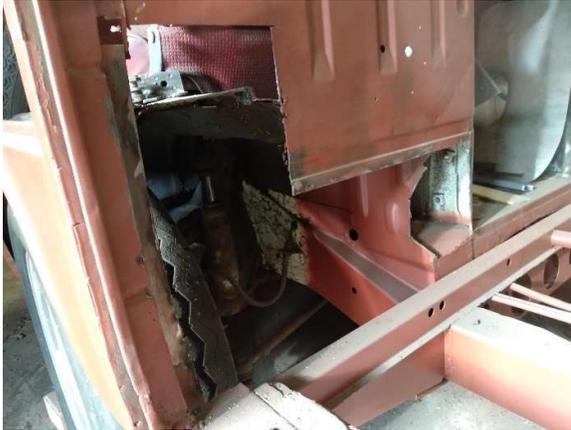
B-post. Behind the front doors and in front of the sliding door / matching other side panel is a pillar called the B post. It is pretty much a hoop of steel that runs from the chassis rail on a T1 to T4 (and maybe later, I have never checked) outwards, up the side of the doors and into the roof. Underneath the vehicle it forms a section strong enough to jack up your vehicle. Maybe. Therefore it all needs to be in good order, made of steel not body filler or rust and importantly needs to be connected at the join from underneath to the side.

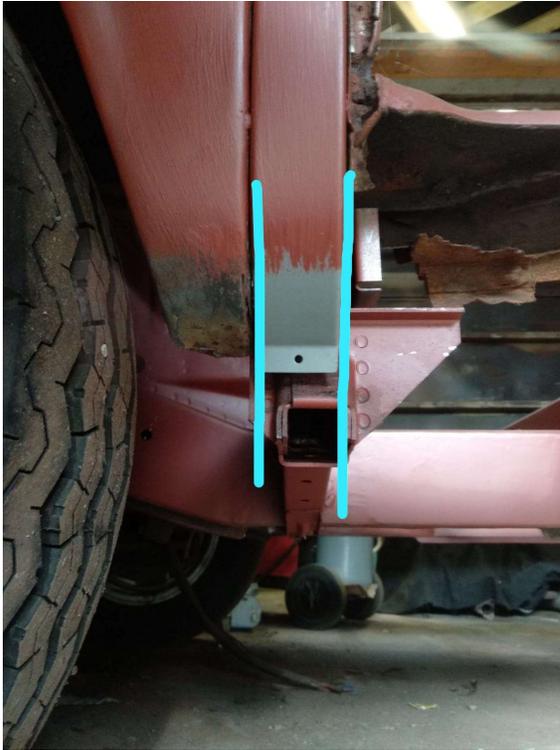
Eric's front cross member that starts this hoop runs across behind the front seats with jacking points below and SHOULD meet the edge of the B post.

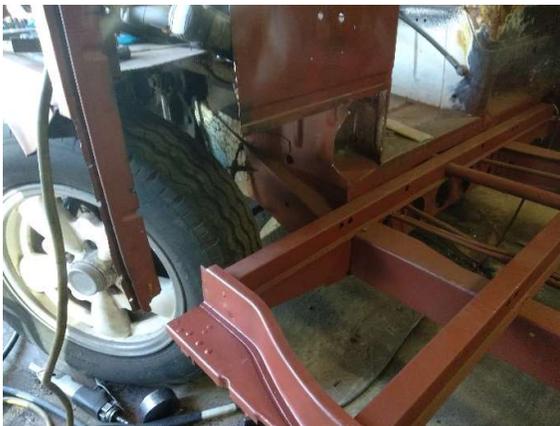
Unfortunately it was 10mm away from lining up and therefore I had fitted the cross member incorrectly. Since that one is parallel to the other 5 cross members, potentially they were all incorrectly placed as well. My heart sank. I enlisted some professional help from a talented friend who just happens to have been restoring VW campers for 30 years professionally and after a good deal of investigating and measuring, we were able to conclude that my cross member was correctly placed. My heart lifted. Unfortunately, my wheel arch, sliding door threshold plate and bottom 12 inches of B post were all in the wrong place. My heart sank. The angle grinder makes short work of removing the incorrectly placed pieces, but that leaves a lot of work to put it all back correctly.

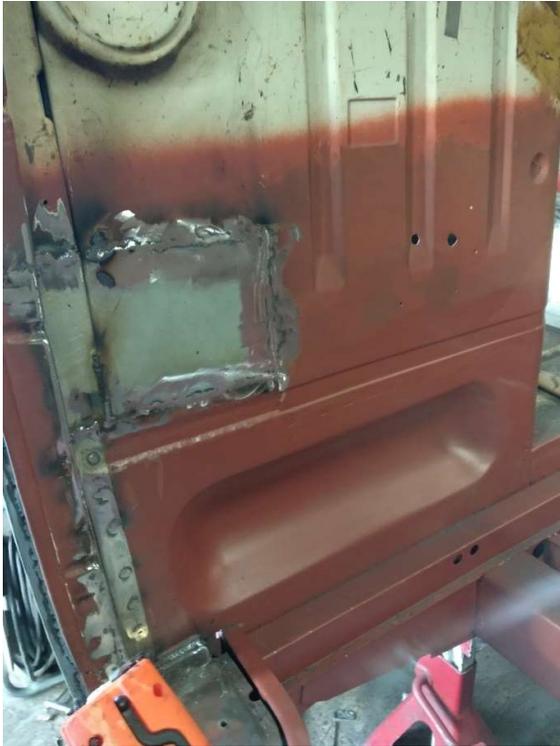
The bulge panel is really just a flat sheet of metal with a dent for the feet of the bus passengers but the bulge does add strength to that panel. That panel forms the front of the B post. Then a “cover” goes on the outside to be visible and the rear side of the square section and the inside piece of the square were fabricated from sheet steel and hammered with the pressings required. Finally a flap coming into the van along the rear of the bulge was folded and this new metal in the shape of a W was welded in. See the spot welds on the back of the bulge panel, attempting to replicate the factory original.
