Eric the Viking – a restoration in many parts – February 2020

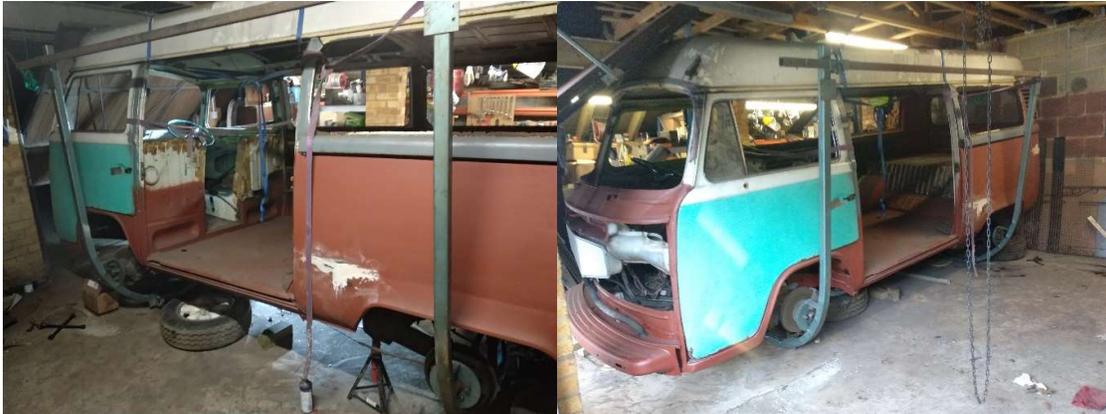
The frame purchased in the Autumn that bolts to the wheel hubs was put into action! Literally remove the road wheel and bolt on this contraption to two wheels on one side.

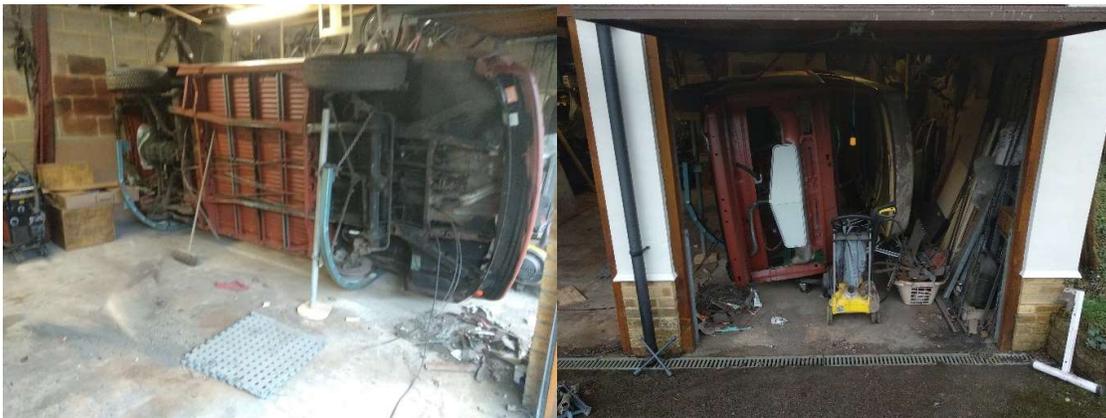
Removing the oil from the engine (I had already removed the engine), water from the washer bottle and fuel from the tank means everything is dry and will not spill. My tank has been empty since I bought Eric 4 years ago! There is a cross member between the wheel pieces to stop them turning the hubs. Then the heart in the mouth moment of attaching an engine hoist on one side, a ratchet strap on the other side and rolling him over. I could not use a traditional spit roast device to turn him since there is no strength in the front at the moment.

And there he was, over. Laying down on his side, exposing his little tummy.
