Eric the Viking – a restoration in many parts – December 2019

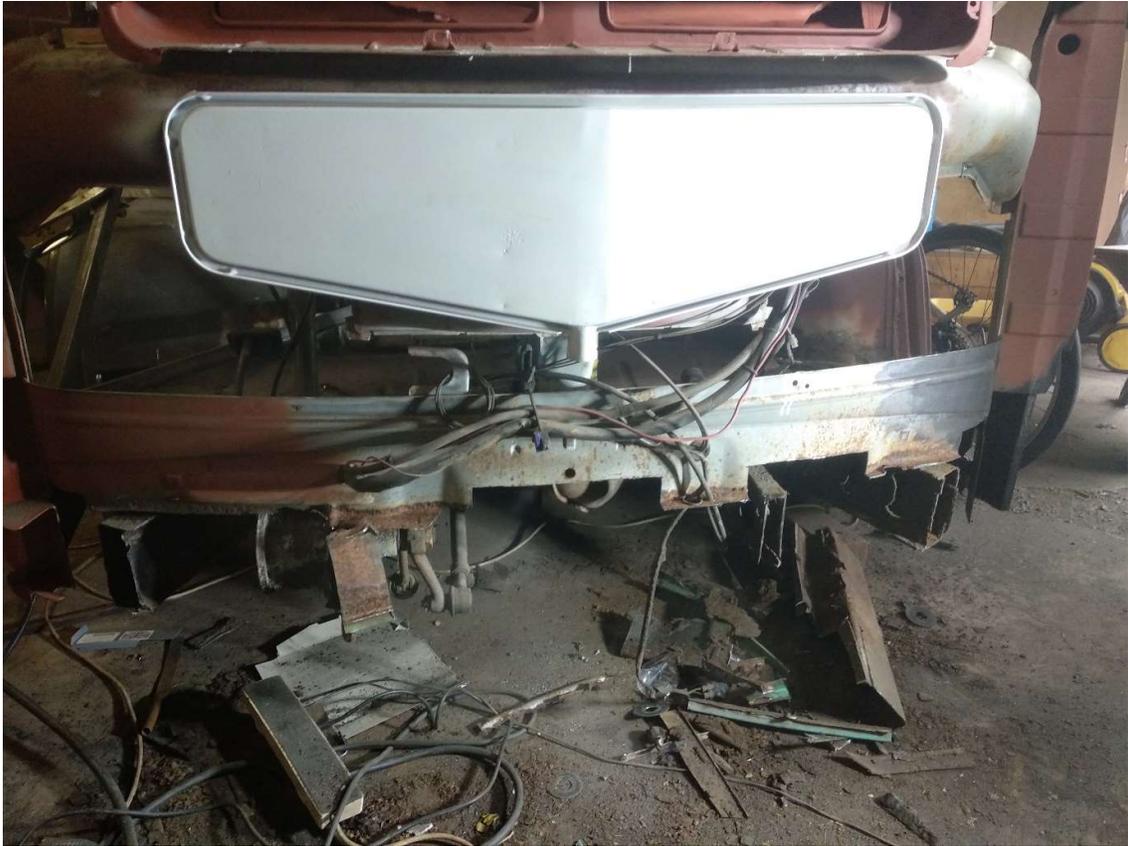
Here is where I started after the last magazine edition:

The bottoms of the A posts were just finished last time and the inner valence that goes between them had been chopped out that looks like an inverted bumper that sits behind the visible bumper. Just like a jigsaw, the valence bone is connected to the A post-bone, you offer up one piece of metal to the next one, jiggle it around until it fits equally left and right, bend it, twist it, trim it slightly because no panel is perfect. Once happy, I have some metal clamps to hold everything in place and the welder comes out.

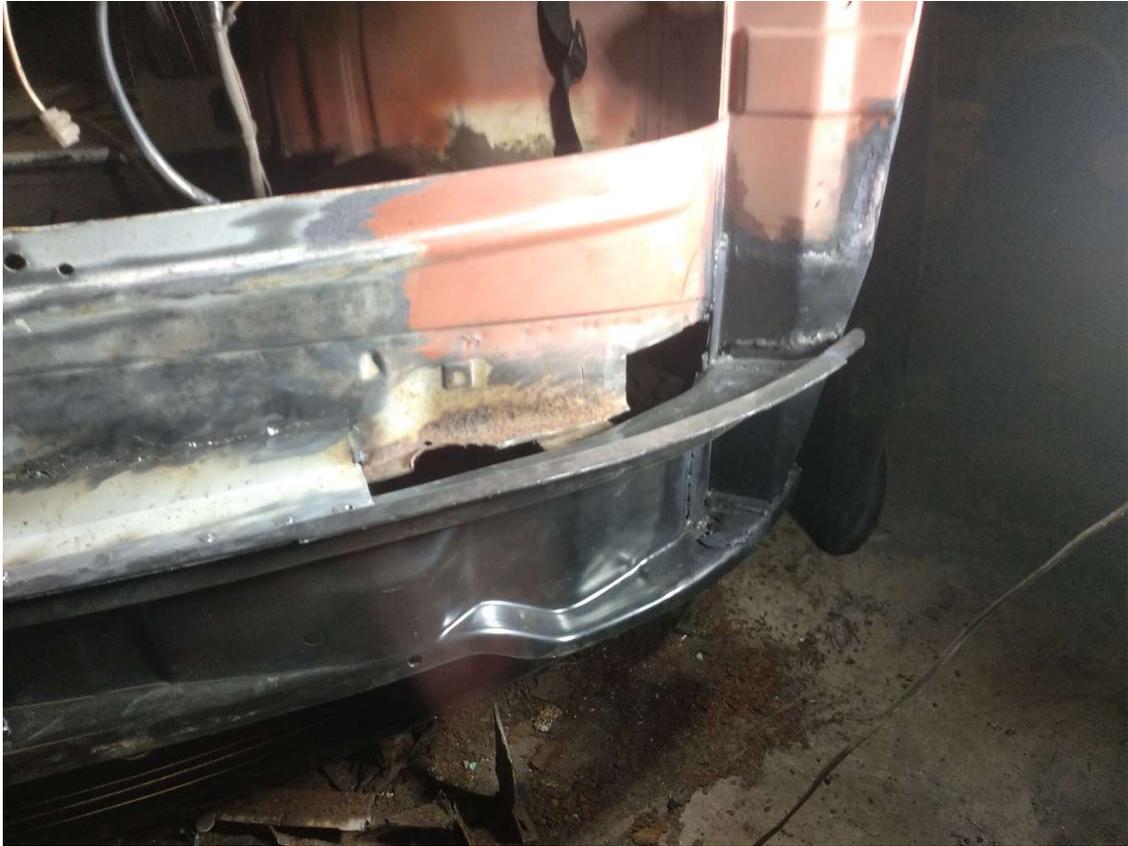
With the inner valence fitted as seen in the above picture, that gave me the correct position of the water bottle panel bottom that was missing as you can see in the same picture. Chop out a section up to a foot across that is rusty and replace it with new sheet metal bent and chopped into shape.

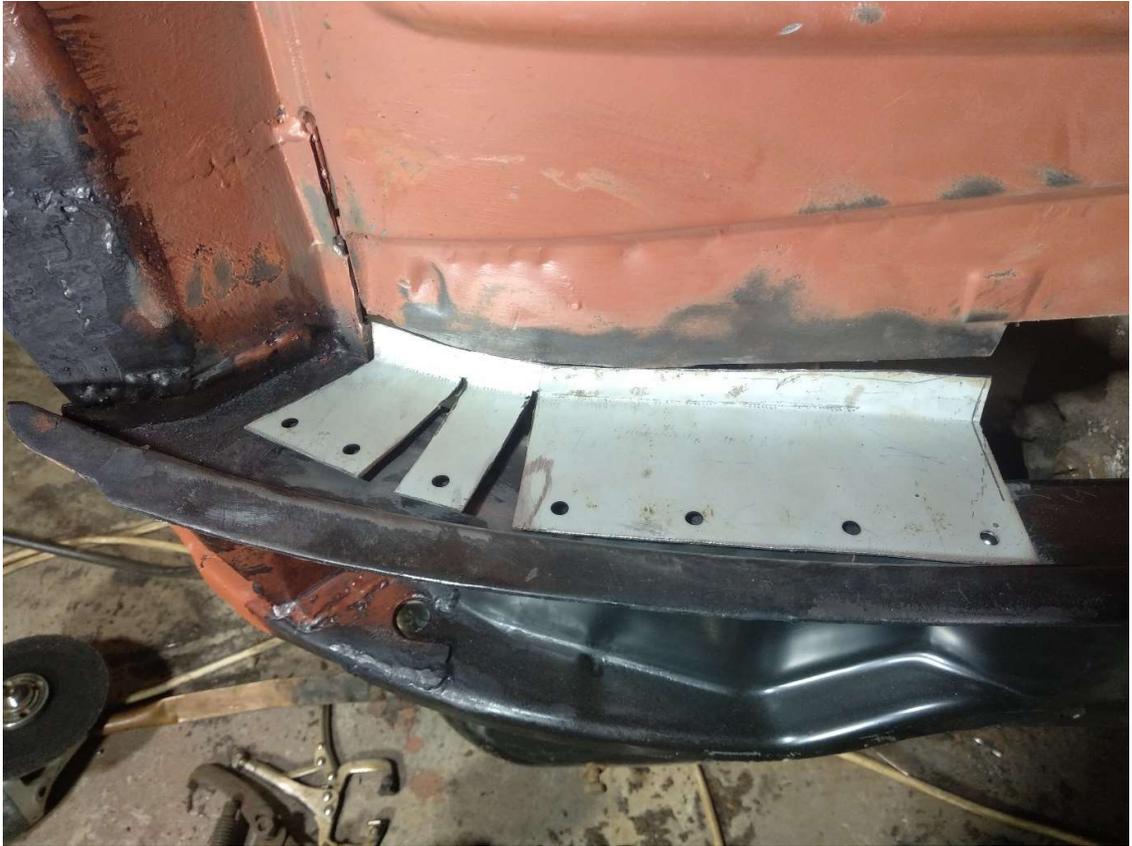
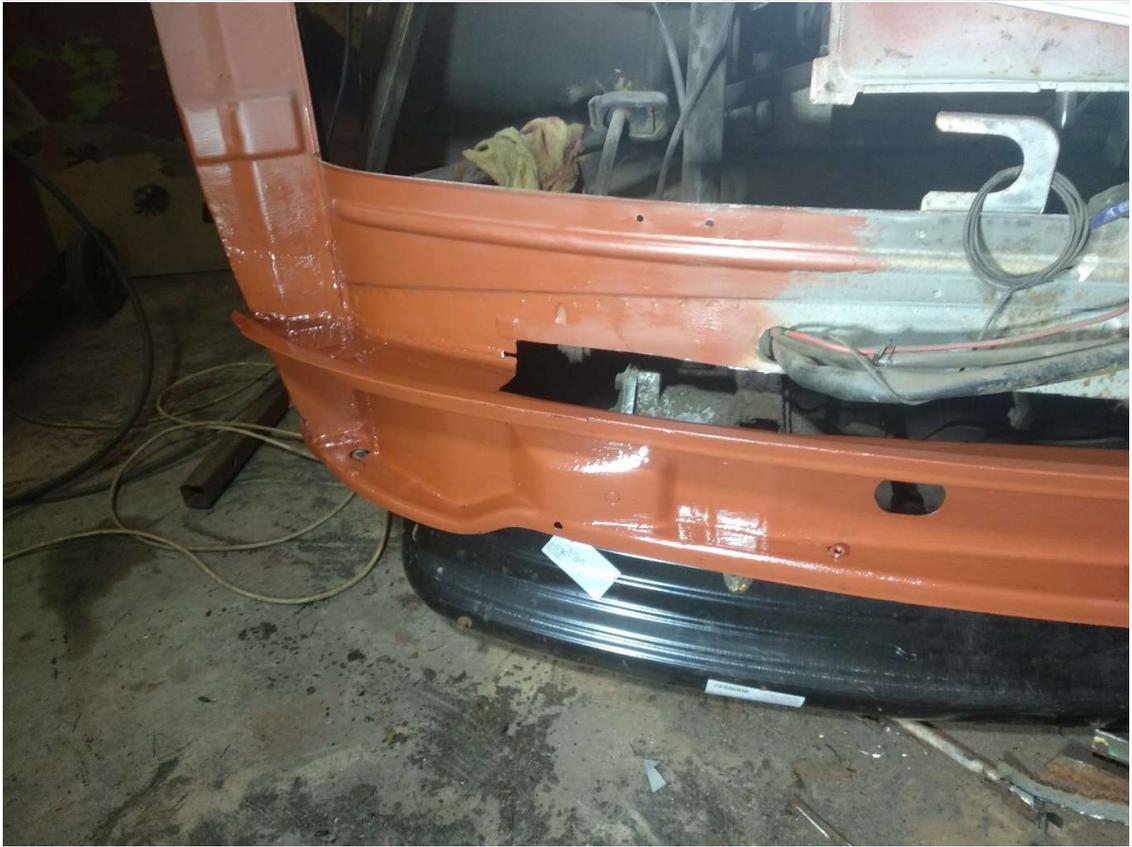
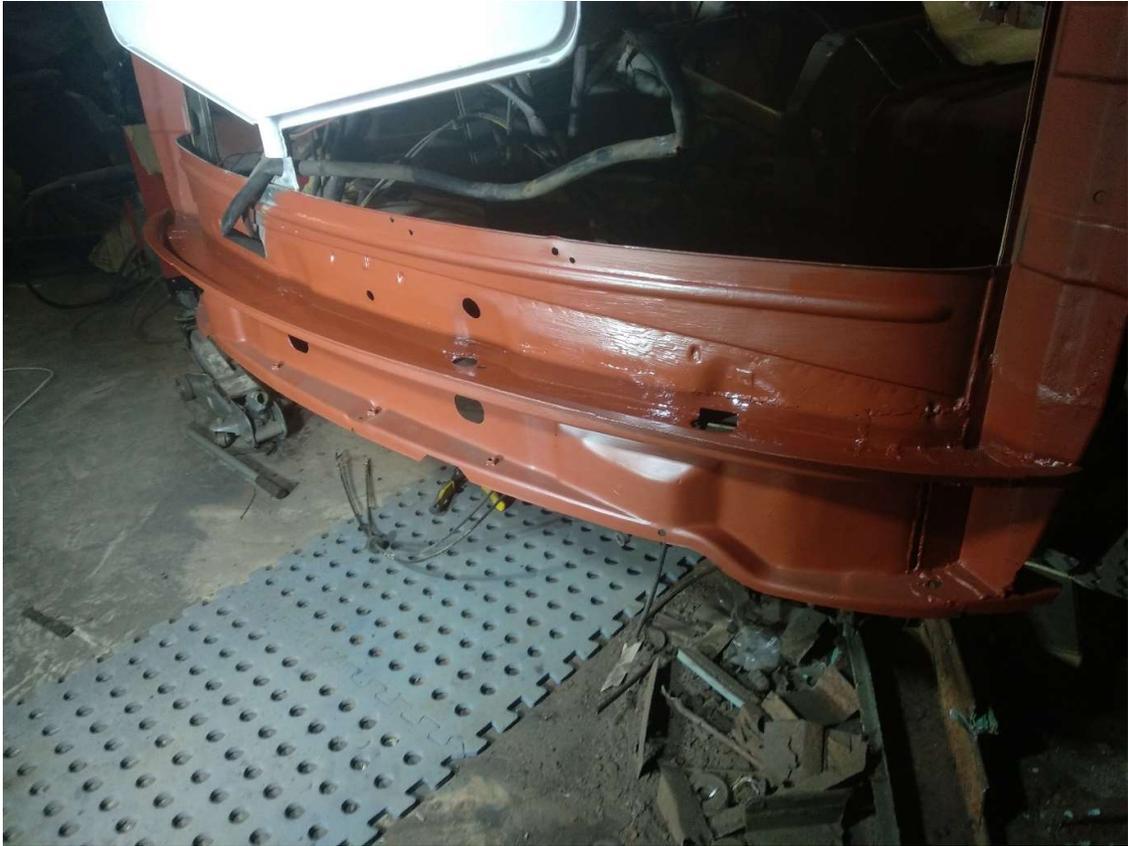
Now the water bottle panel is joined back to the inner valence hopefully keeping the water out apart from the holes for wiring and ducting which will receive new grommets in due course. At each point, the bare metal gets a paintbrush coat of anti-rust solution (Kerust), then once that dries black, it gets brush painted with anti-rust primer (Rustoleum). Many other products are on the market and I could spray it to get it smoother but my emphasis is on coverage and protection on these hidden parts, not perfection of smoothness.

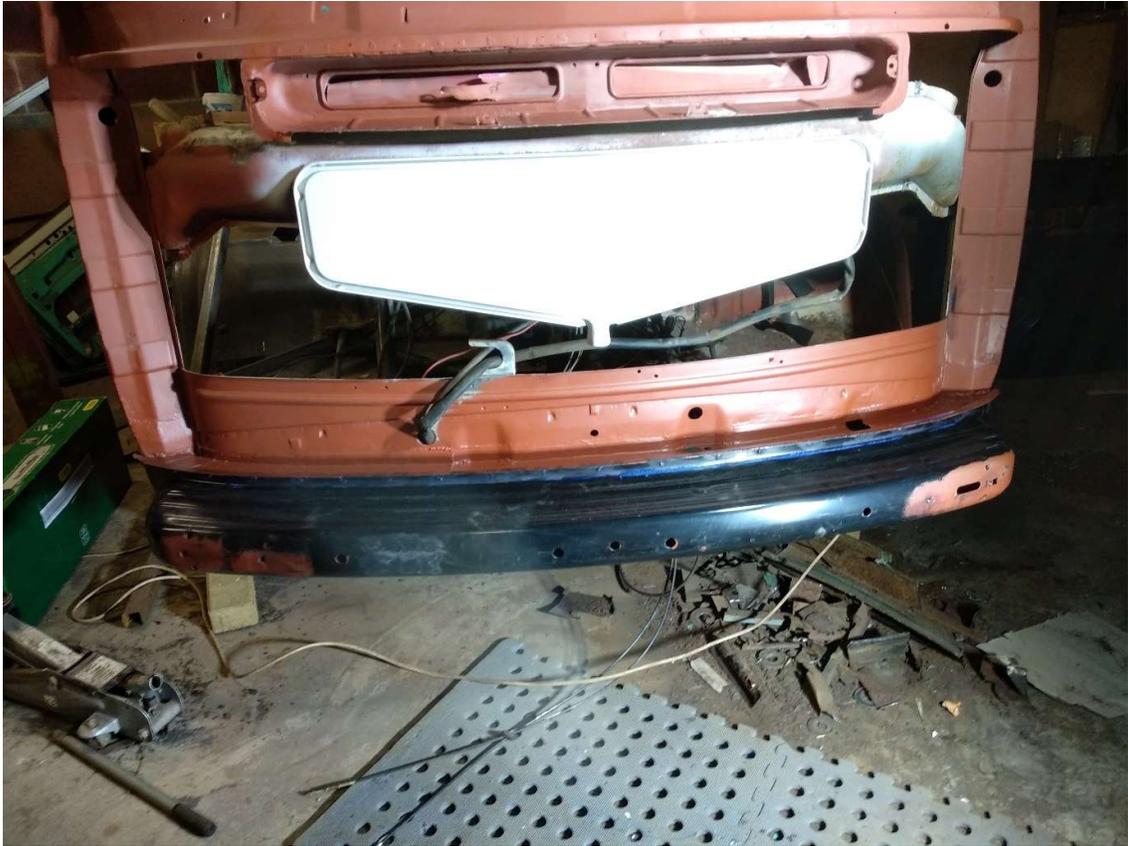
Finally, the deformation panel can be welded onto the inner valence to provide a huge amount of strength and something of a crumple zone.
